Thermal Effects of Artificial Lamination Faults in a Three-Phase Transformer Core Using Infrared Thermography

Ehsan Altayef, Sofiane Chiheb, Fateh Anayi, Michael Packianather and Eheda Hassan

Abstract—Transformer core lamination faults can significantly affect transformer performance, reliability, and operational lifetime by increasing core losses and localized heating. This paper investigates the thermal effects of edge burr faults and inter-laminar insulation deterioration. An experimental test rig consisting of a 15 kVA three-phase transformer and a FLIR C2 thermal imaging camera was developed to capture temperature distributions under healthy and faulty operating conditions. Faults were introduced by creating controlled short circuits between laminations with varying affected areas and numbers of shorted laminations. Thermal images were acquired at different magnetic flux densities ranging from 0.5 T to 1.8 T under no-load conditions. The results demonstrate that both fault types produce noticeable temperature rises compared with healthy operation, with the severity of heating increasing as the flux density and fault size increase. Edge burr faults resulted in localized hot s

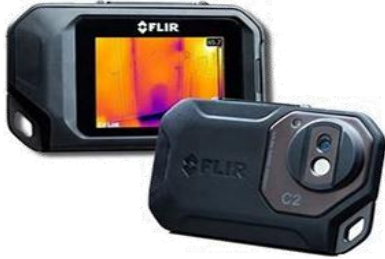
Fig. 5: Thermal camera

magnetic flux density levels to evaluate the influence of the investigated lamination faults on the transformer core temperature distribution. A FLIR C2 thermal imaging camera was used to record all thermal images. For each fault scenario and flux density level, six thermal images with a resolution of 80×60 pixels were captured at 15-minute intervals throughout the experimental period. This acquisition procedure ensured consistent monitoring of the temperature evolution under each operating condition. The specifications of the FLIR C2 thermal camera are summarised in Table 1.

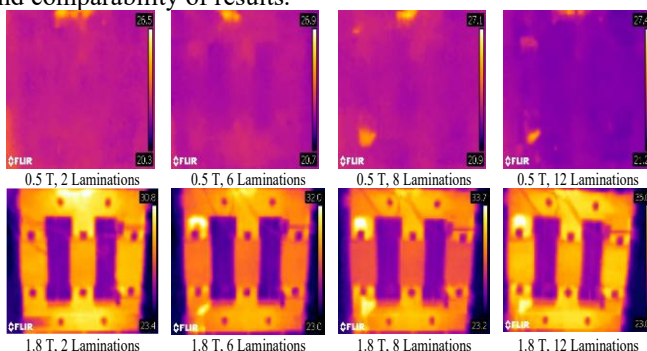
Fig. 10: Faulty operation mode results at 0.5 and 1.8 T

In this section, the thermal imaging results for the second type of fault, namely inter-laminar insulation degradation, are presented. This fault was introduced by selectively removing the insulating coating from the transformer core laminations, thereby creating electrical contact between adjacent layers. Figure 10 illustrates the corresponding thermal images of the transformer core under fault conditions.

The results correspond to short-circuit conditions involving 2, 6, 8, and 12 affected laminations, evaluated at magnetic flux densities of 0.5 T and 1.8 T. It should be noted that the influence of fault location on the position of the inter-laminar short circuit has been previously investigated using current signal analysis in [27]. In this study, the same fault placement strategy and positioning methodology were adopted to ensure consistency and comparability of results.

From the results presented in this figure, it is evident that the size of the fault, defined by the number of short-circuited laminations, has a significant influence on the transformer core temperature. The thermal measurements indicate that the temperature increases as the number of affected laminations increases, as illustrated in the figure. Specifically, the figure presents the maximum and minimum temperature values as a function of the number of affected laminations at magnetic flux densities of 0.5 T and 1.8 T.

The results demonstrate that the temperature rise associated with inter-laminar insulation faults is strongly dependent on both the number of shorted laminations and the applied flux density. For fault cases involving 2, 6, 8, and 12 short-circuited laminations, the highest temperatures are observed at a flux density of 1.8 T, with increases exceeding 9 °C compared with the corresponding values at 0.5 T for the 12-lamination fault scenario. For the case of two shorted laminations, the temperature increases by more than 4 °C across the flux density range from 0.5 T to 1.8 T. In addition, temperature rises of approximately 6 °C are observed for the six- and eight-lamination fault cases over the same flux density range.
